smartWLI nanoscan

Halle KNT 4058/01

Normal zum Kalibrieren und Prüfen von Messgeräten zur Bestimmung von Oberflächenrauheiten entsprechend PTB-Normalen

Standard for calibration and testing of Instruments for surface roughness measurement corresponding to PTB-standards

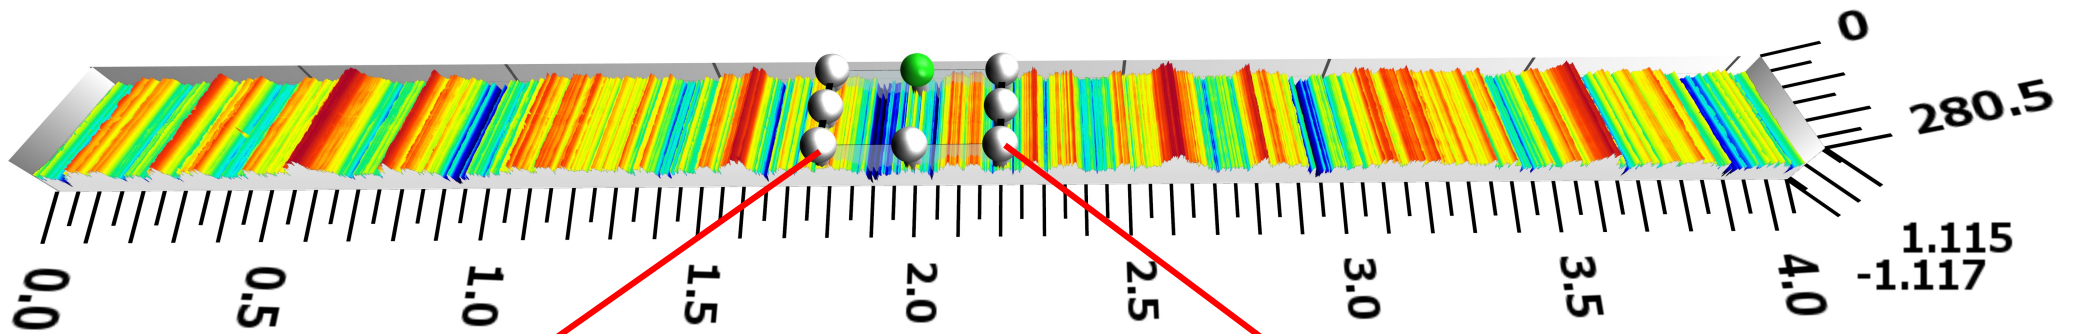
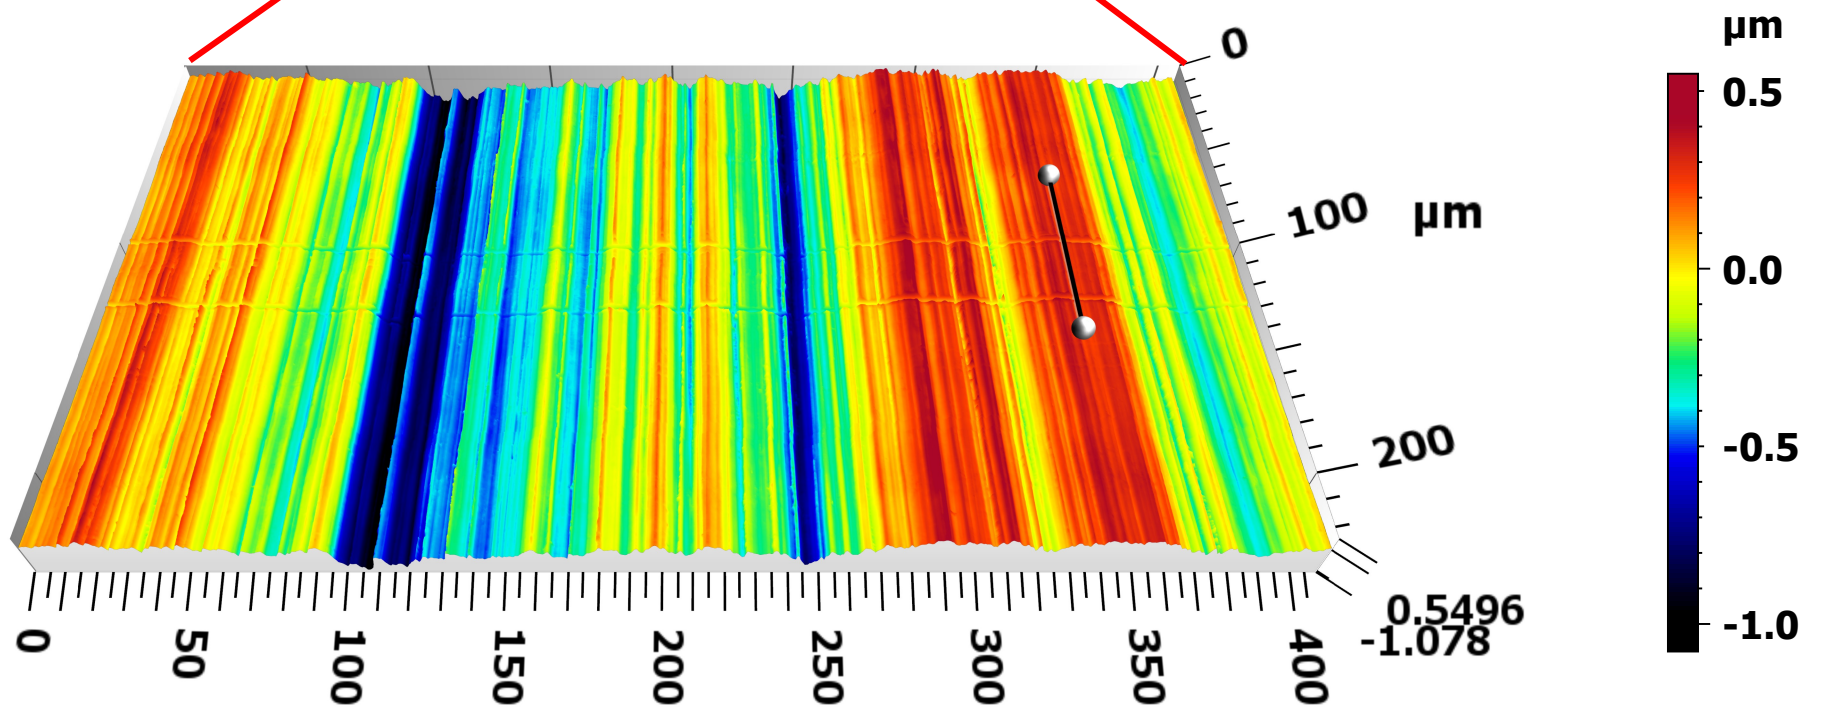
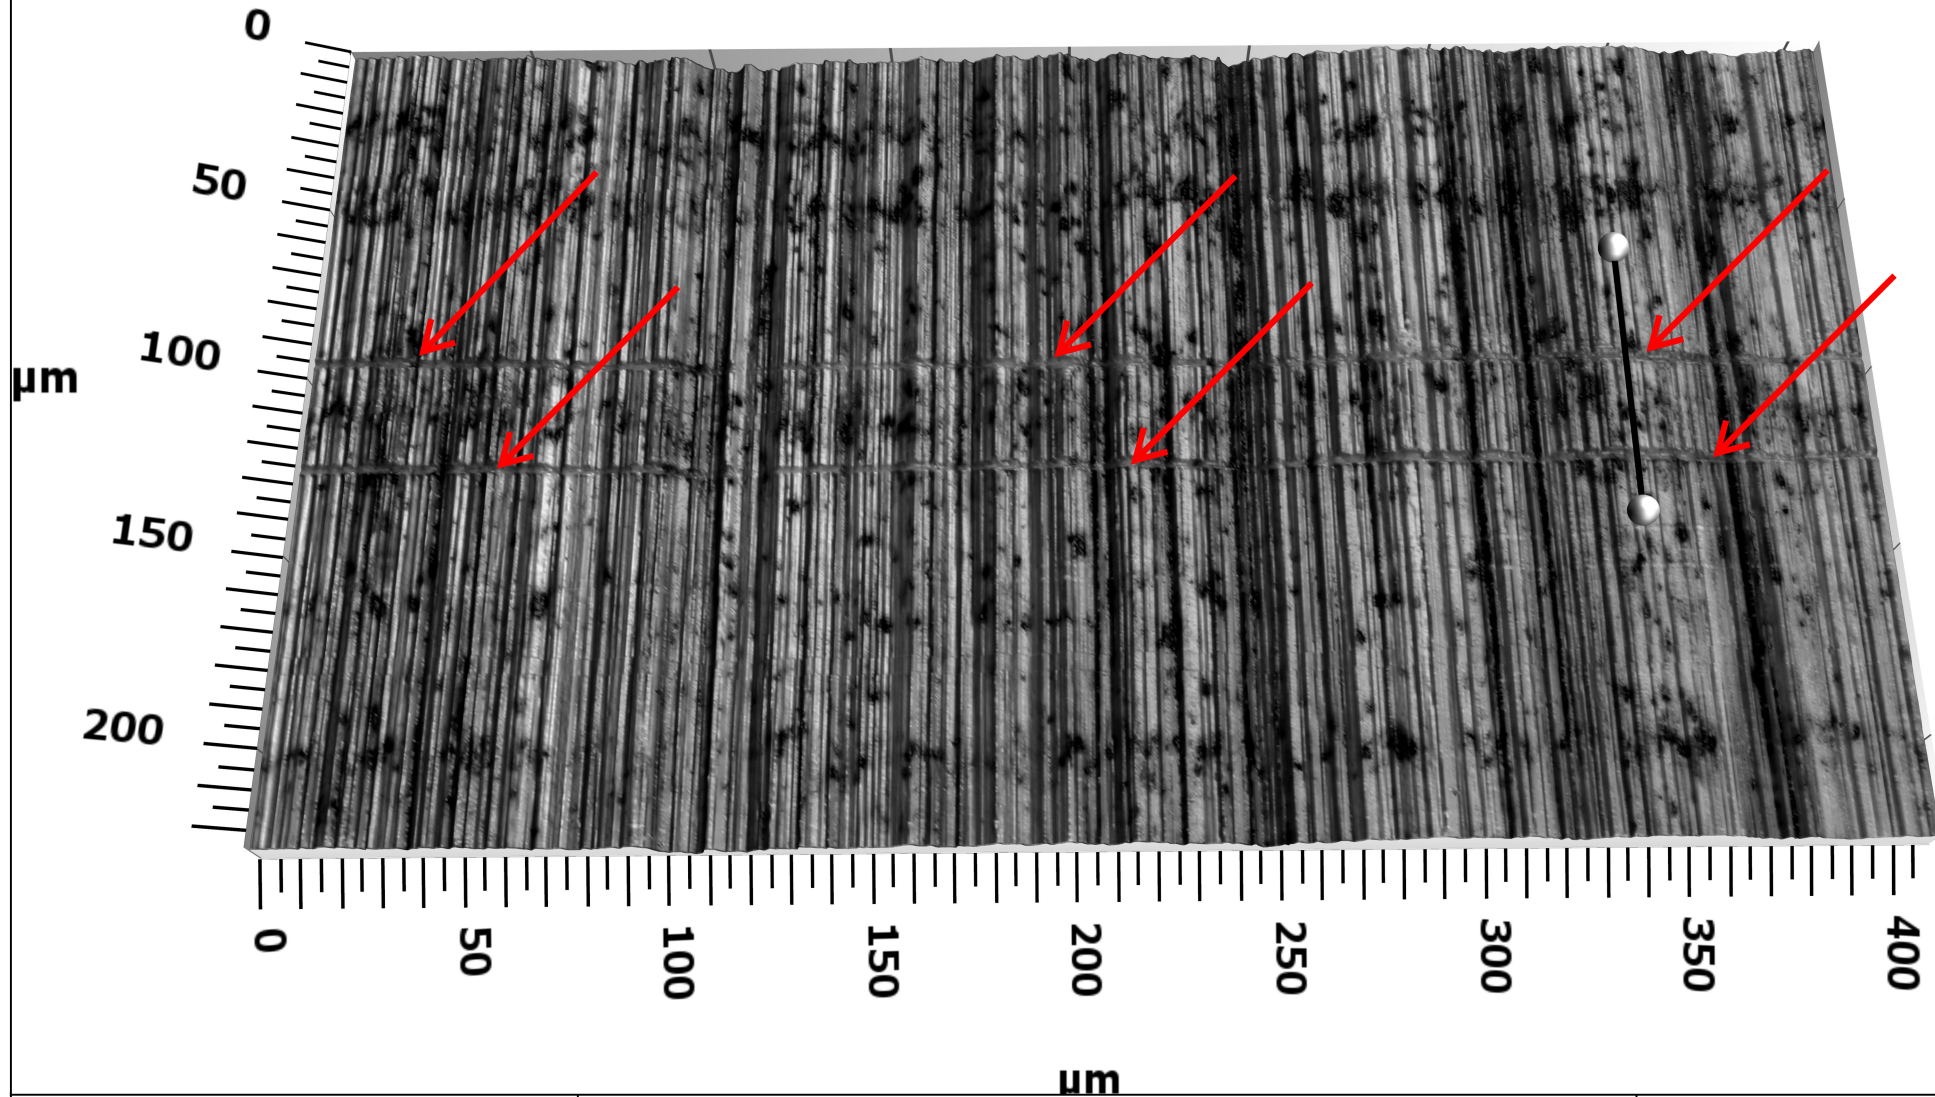
Parameters	Value	Unit
Length	75.82	μm

- app. 14.000 measuring points inside the area of the stylus tip with a diameter of 4 µm
- the complete area - 4000 x 300 µm² was scanned with 1.100 Mio. measuring points and 133.000 points per profile

- stylus instrument MahrSurf XR20
- tip radius < 2 µm
- static measuring force 1mN
- the standard was exclusive used for calibration of optical measuring systems
- app. 10.000 measuring points per profile

Since the standard was never used from GBS for stylus measurements we have to suspect, that the standard was damaged from the certification themself.

Citation out from Halle:***"Damages of the surface can be avoided in this way:***

Do not use broken stylus tips. Avoid abrupt touch down of the stylus. Avoid jerky shifting of the standard below the touched down stylus. Avoid extremely high pressure of the stylus as for example at inexpertly alignment. Repolish the skid if necessary."

Many standards which are continuously used to calibrate stylus instruments are in much worse conditions and could cause wrong measuring results. Out of this reasons stylus tips and surface standards need a continuously curvey.

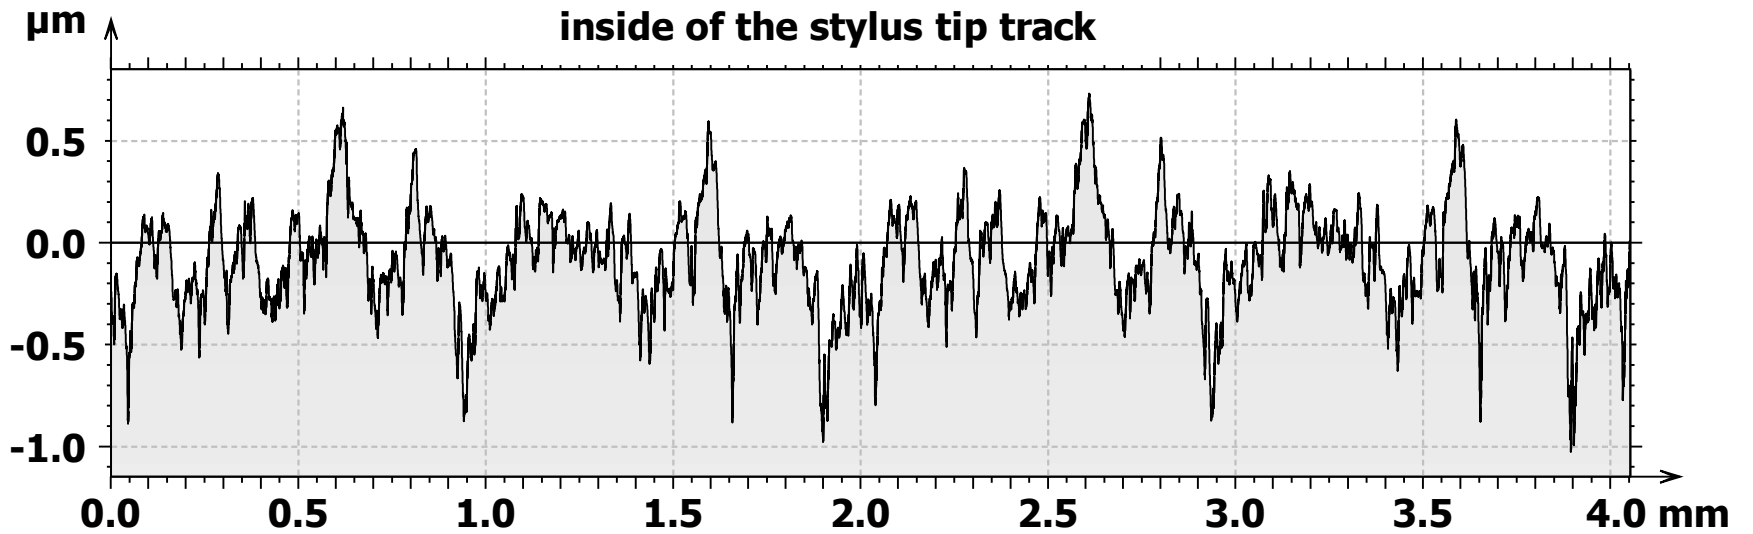
ISO 4287 - Roughn...

F: None
 S-filter (λ_s): Gaussian, 2.500...
 L-filter (λ_c): Gaussian, 0.8000...
 Calculated on: All λ_c (5)

Amplitude parameters

Rp	0.6435	μm
Rv	0.7505	μm
Rz	1.394	μm
Rt	1.496	μm
Ra	0.1780	μm
Rz1max	1.454	μm

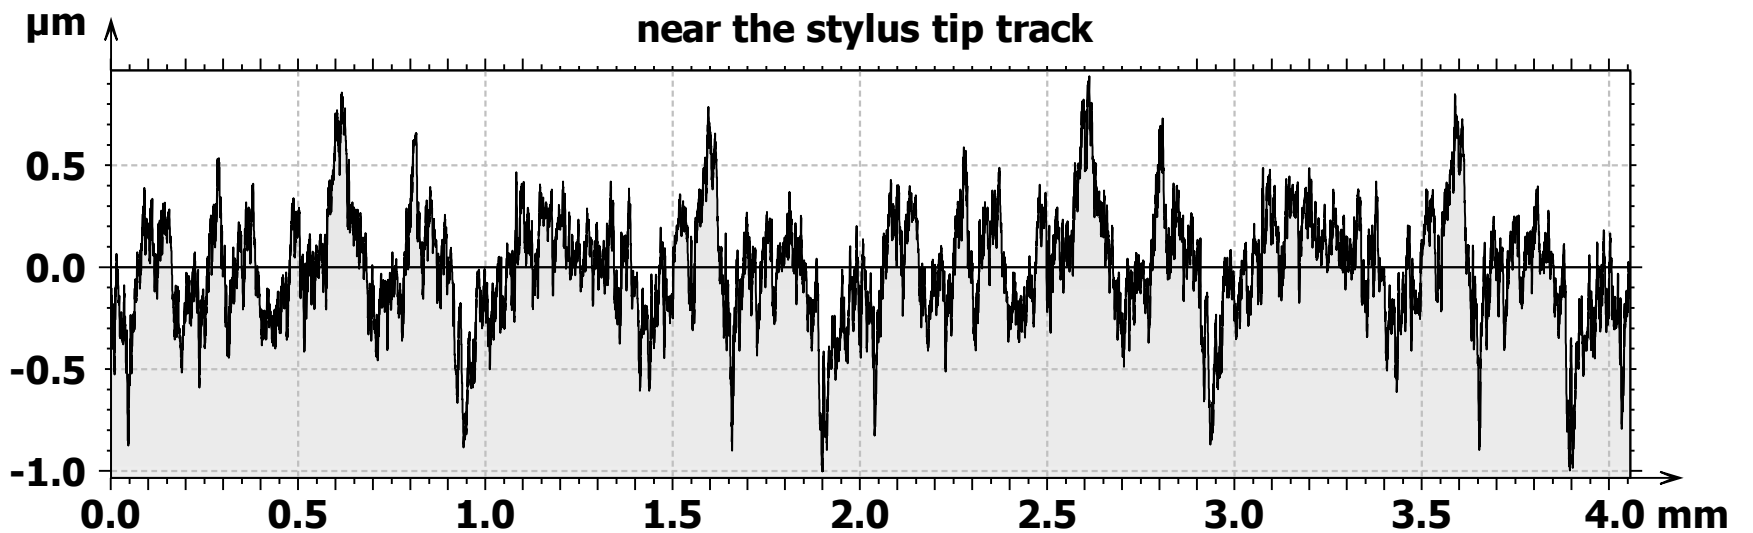
ISO 4287 - Roughn...

F: None
 S-filter (λ_s): Gaussian, 2.500...
 L-filter (λ_c): Gaussian, 0.8000...
 Calculated on: All λ_c (5)

Amplitude parameters

Rp	0.7434	μm
Rv	0.8311	μm
Rz	1.575	μm
Rt	1.670	μm
Ra	0.2010	μm
Rz1max	1.666	μm

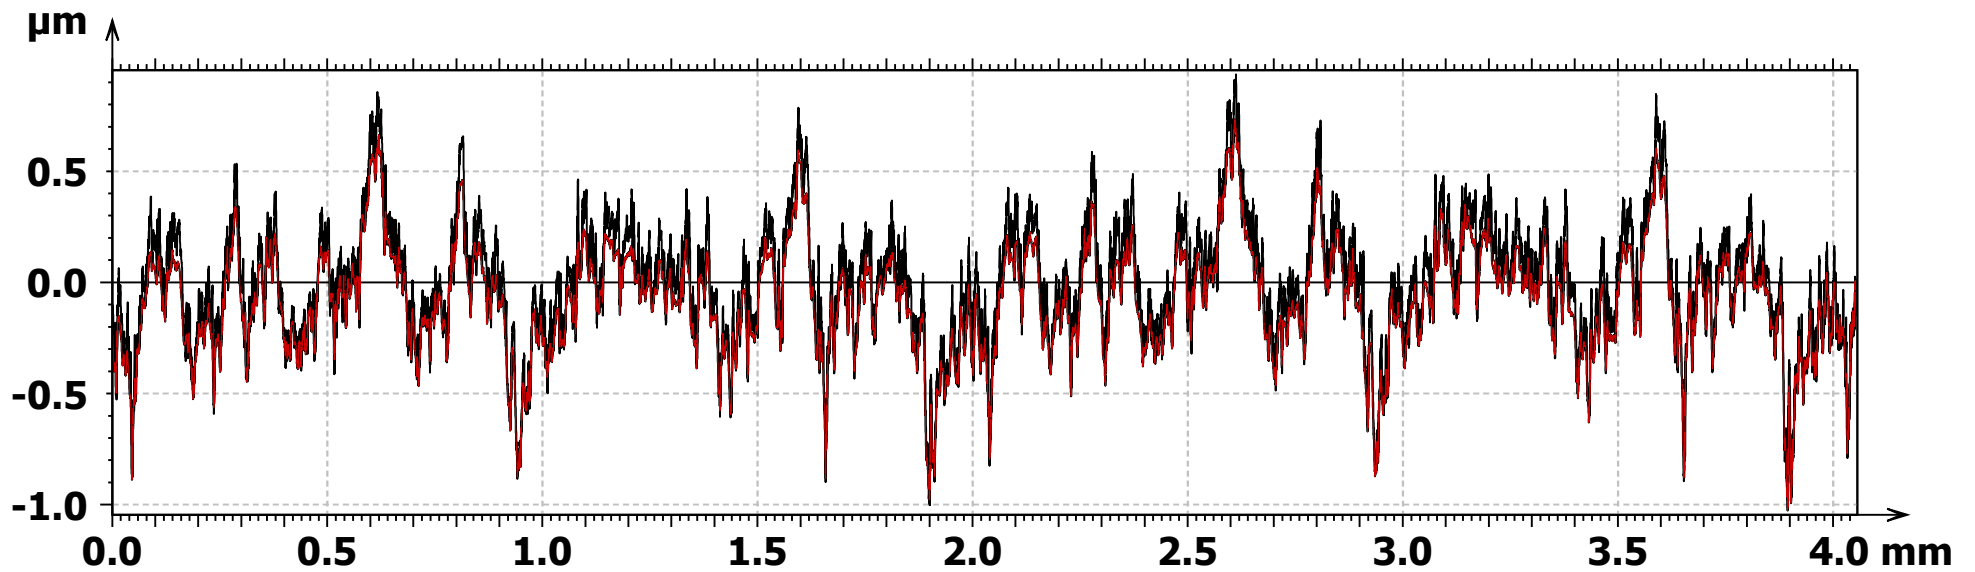
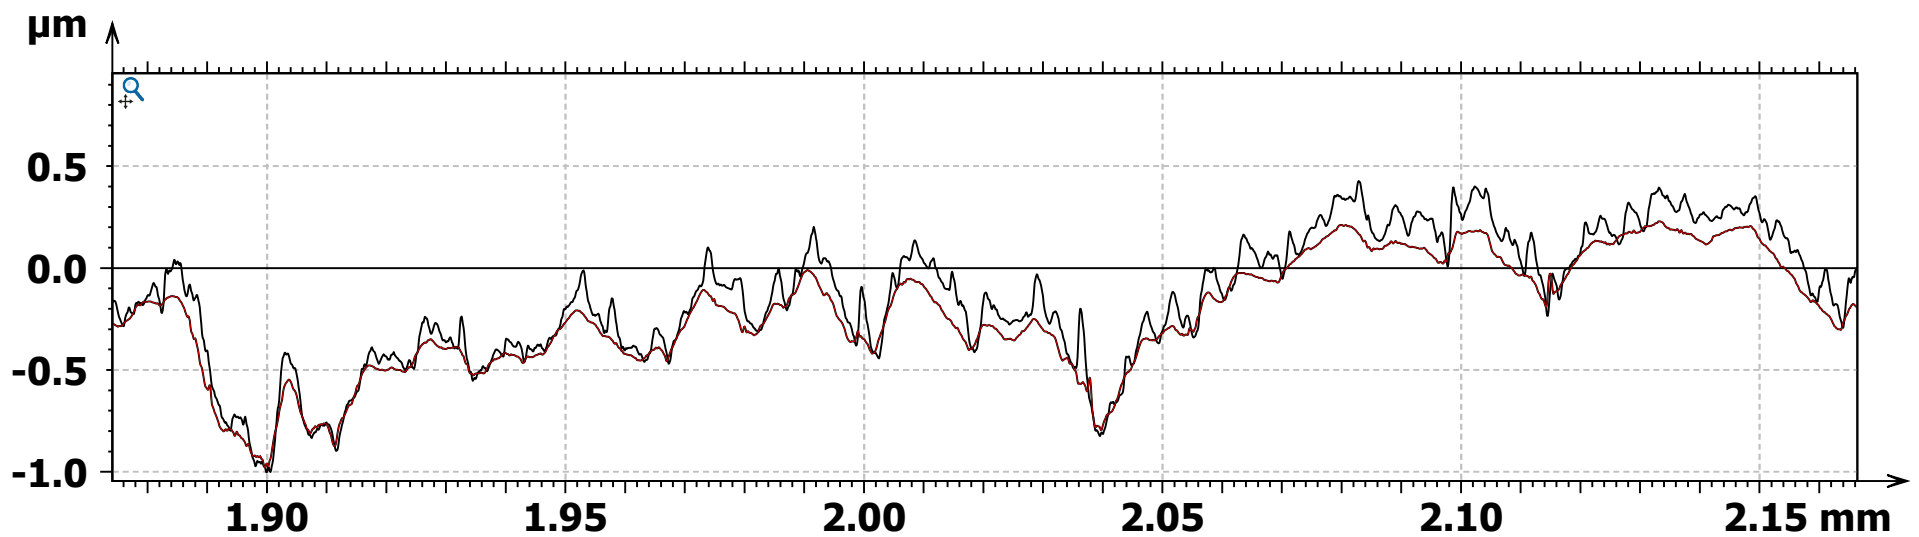
It seems problematic to check the stylus tip after each measurement and the ISO regulation is mentioning a tip radius $< 2 \mu\text{m}$ which could be also true for a damages tip.

The measured abrasion exceed 200 nm and has a significant impact to measured roughness values.

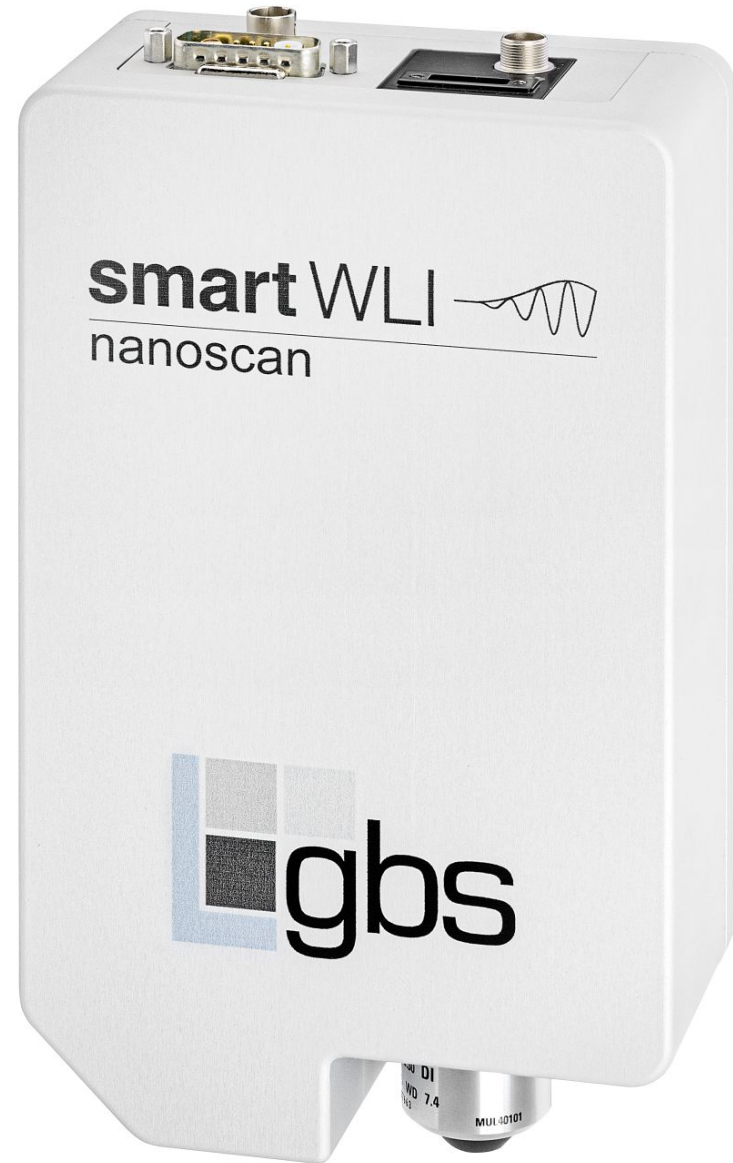
- 220 single scans with 5MP
- point density xy 0.03 µm
- system noise z 0.03 nm
